Date---09/07/2007 Affected Equipment—All Digger Derricks Reason---Worn Auger Bolt/s

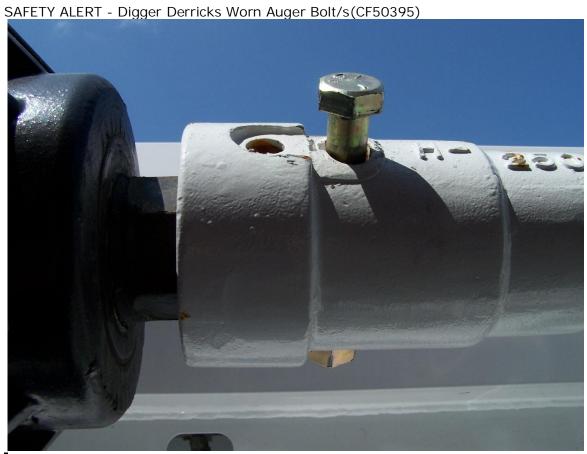
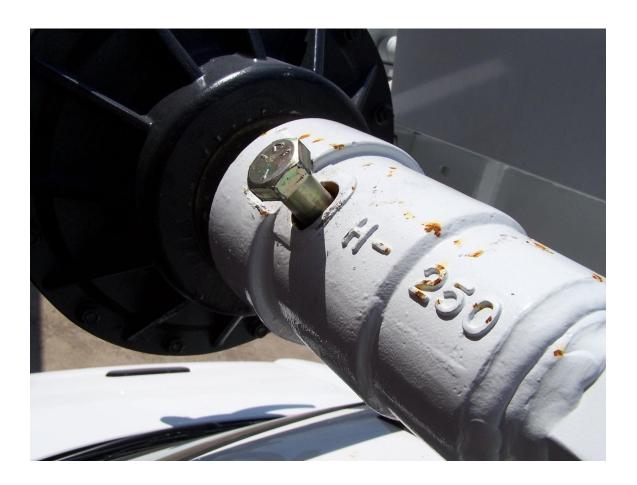
Over the last couple of months several instances of worn auger bolts have been found. In several cases Distribution has generated Near Miss concerning these bolts, the most recent in Arkansas. Attached is drawing indicating the location of these bolts. In most cases these are ³/₄ Inch grade 5 bolts.

Each operator should perform or coordinate with local mechanic or shop to have bolts inspected as soon as possible. Worn bolts should be replaced with manufacture recommended fasteners. These bolts should be inspected by operator on monthly vehicle inspections and visually prior to un-stowing auger. Do NOT un-stow the auger until all persons are clear of the area. A free swinging auger can cause DEATH OR SERIOUS INJURY.

At the next scheduled TSAB (Transportation Advisory Board Meeting), the team will evaluate the need for scheduled replacement of these bolts as part of PM and contact the manufacture of equipment to determine if this problem is being experienced with other users.
